# SCDOT CMRB and Other Paving Updates

Jay Thompson, PE  
State Pavement Design Engineer  
SCDOT - Office of Materials and Research

# Overview

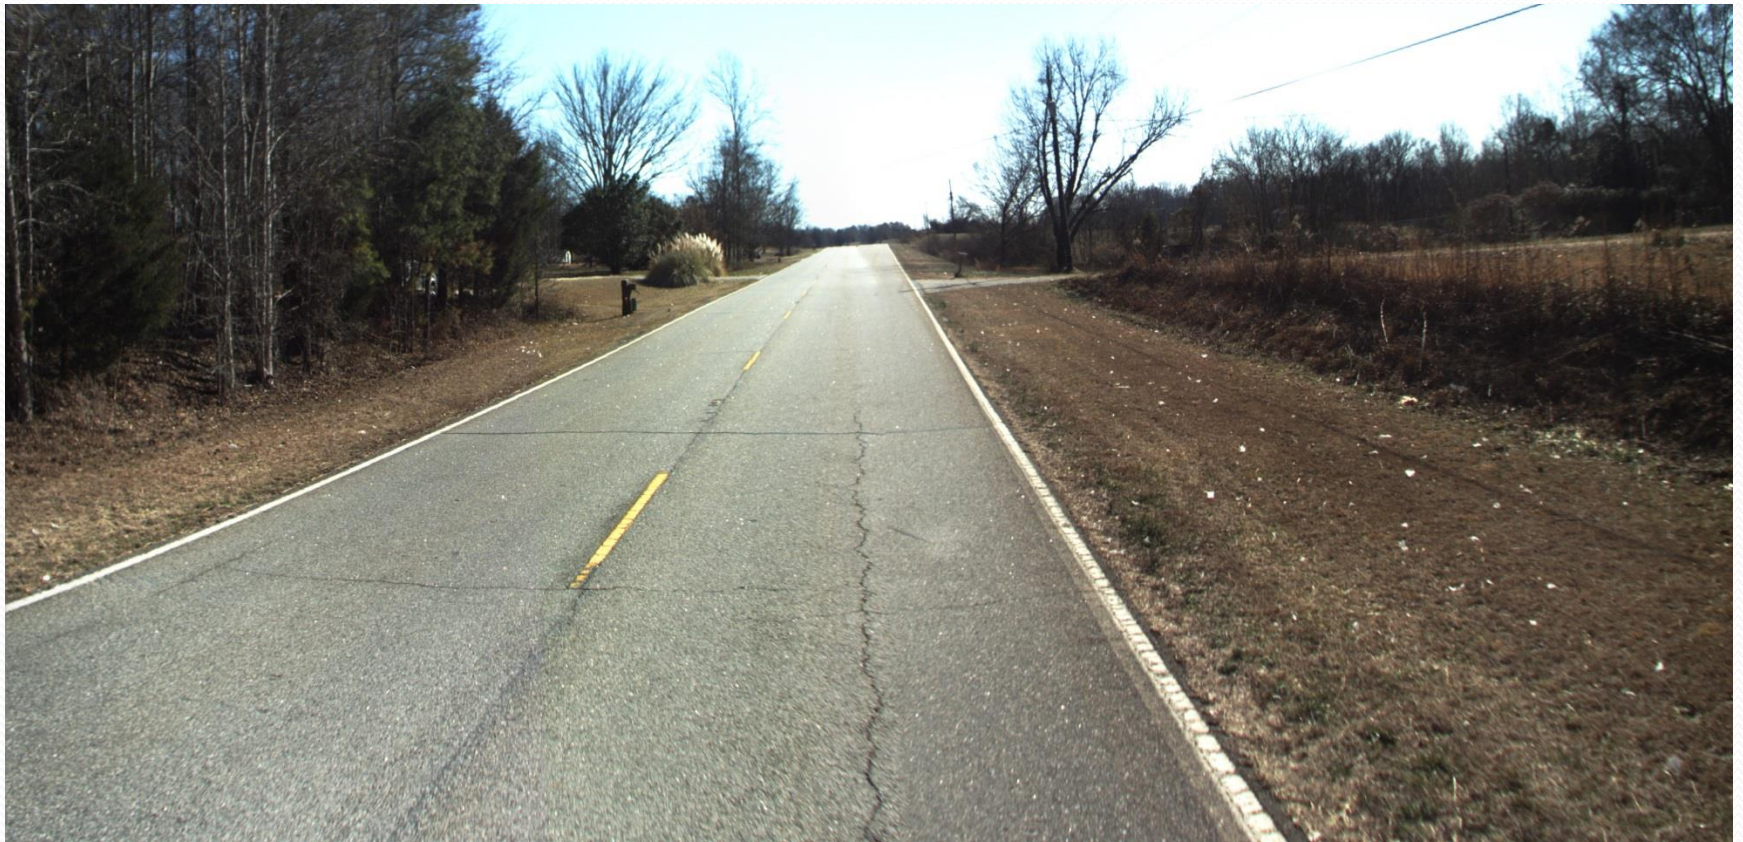
# SC Route 97 (2013)

9 Inches CMRB, 225 psy Intermediate, 175 psy surface

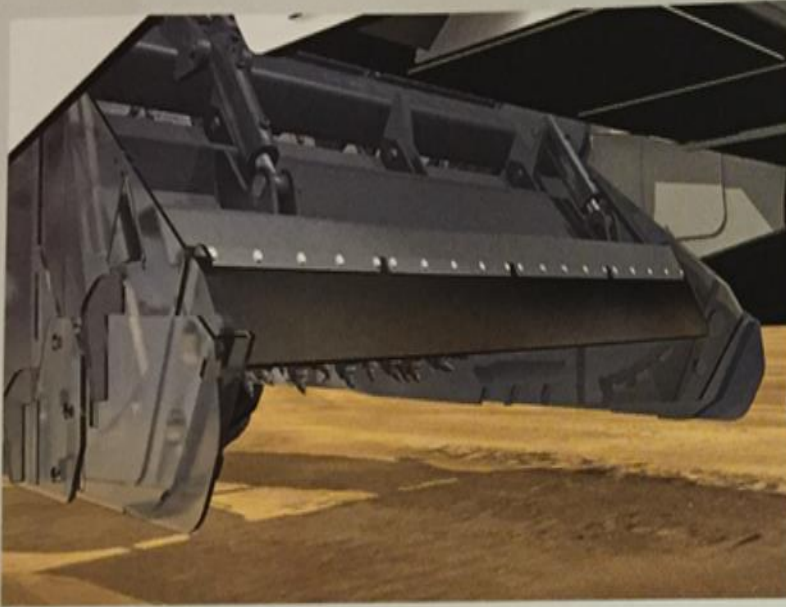
The front rotor plate opens wide and is equipped with a crusher bar ...

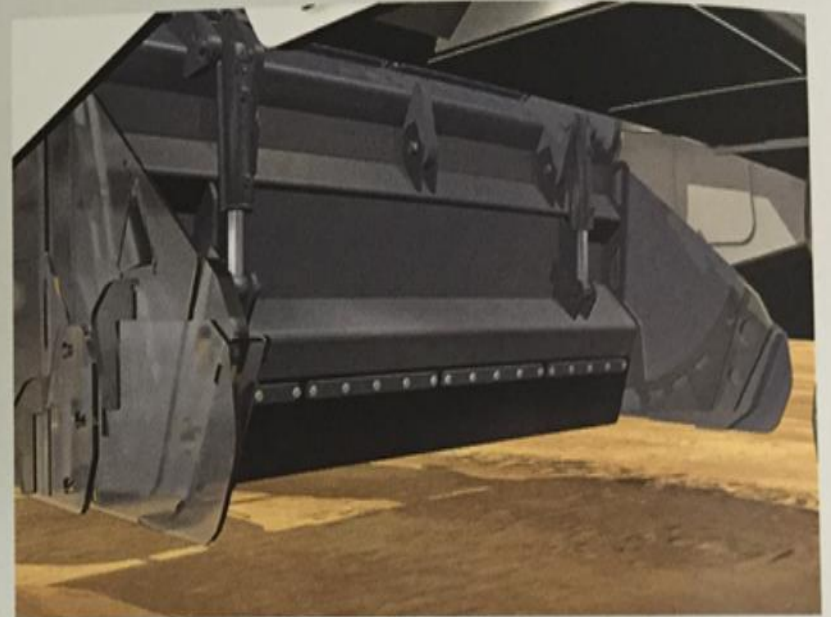
... which can be adjusted to produce the specified particle size

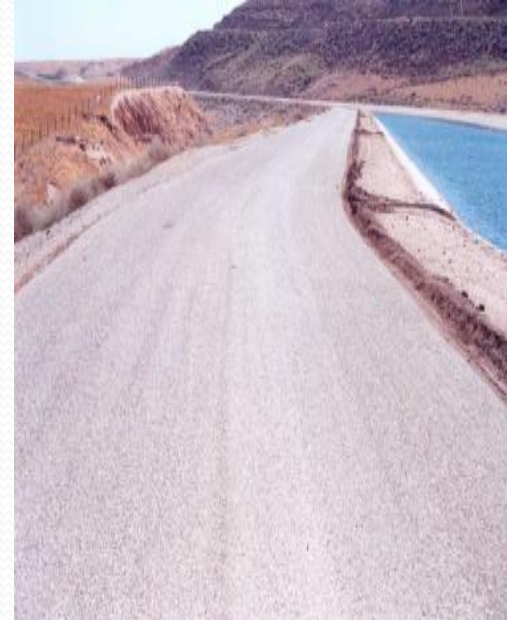
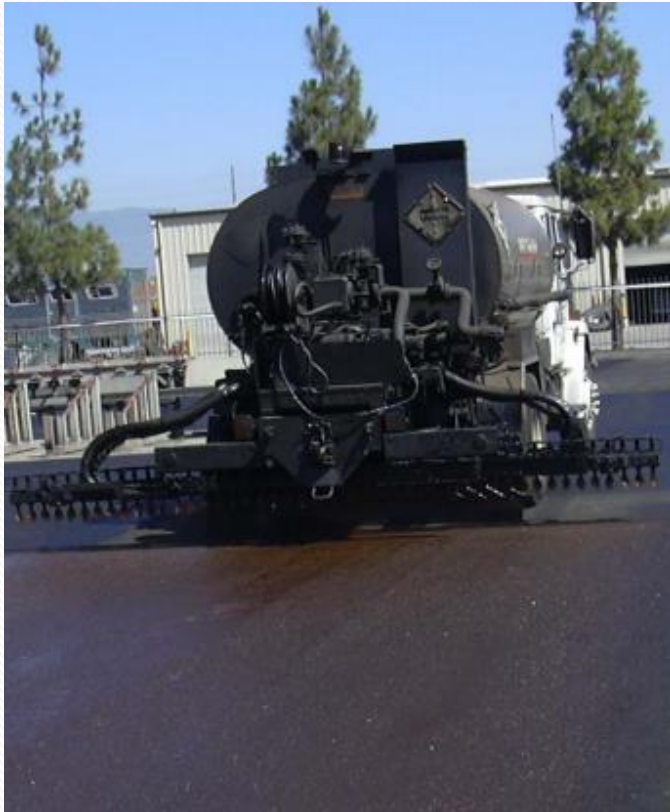
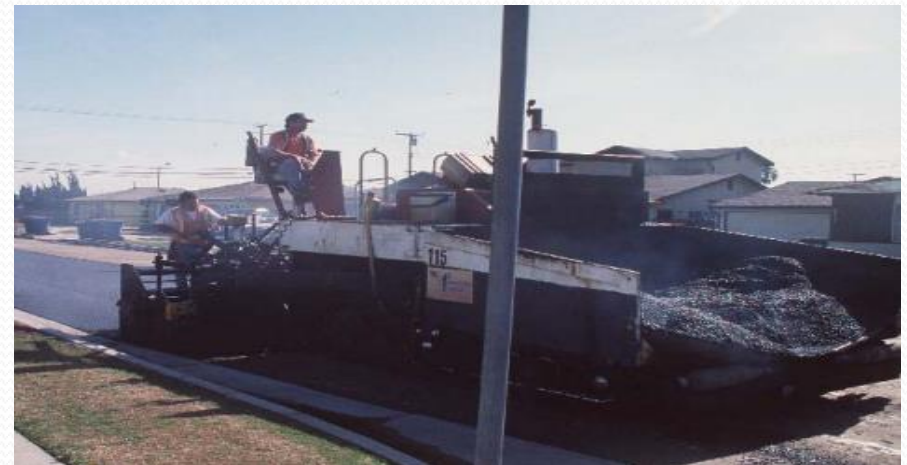
# CIR

Because of higher void ratio's CIR/CCPR surfaces must be sealed.
